TECHNICAL MEMORANDUM TM X-53653

INVESTIGATION OF SOLDER CRACKING PROBLEMS ON PRINTED CIRCUIT BOARDS

RESEARCH AND DEVELOPMENT OPERATIONS
QUALITY AND RELIABILITY ASSURANCE LABORATORY

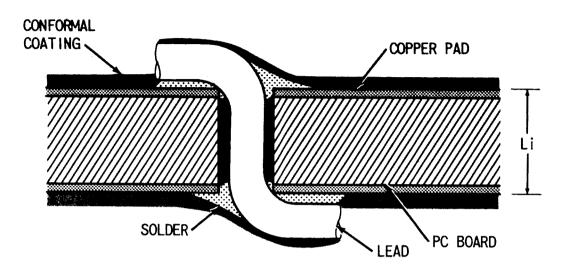
Figure 1. Temperature-Expansion Relation

- 2. As seen in figure 1, any thermal excursion is accompanied by a change in PC board hole length and simultaneous change in component lead length. Thus any differences in the thermal coefficients of expansion will generate a force at both soldered connections. Obvious factors that affect the degree of cracking are: the thickness of the PC board (L_i), the temperature cycling that the PC board has been subjected to (ΔT), and the difference of coefficients of thermal expansion of the lead material and the glass-epoxy board. The temperature-expansion relationship is as follows:

3. Thus, it can be seen that even a small change in temperature, as experienced "on the shelf" during storage, can cause stressing in a solder joint. The smaller the ΔT , the smaller the applied stress. However, according to the metallurgical characteristics of solder, it does not require a great force to cause a creep-rupture type failure in a soldered connection. Reports by the IBM and Martin Companies indicate this failure mode can be induced with less than a two pound force in a time frame of a week or less.

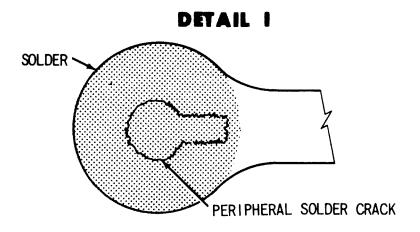
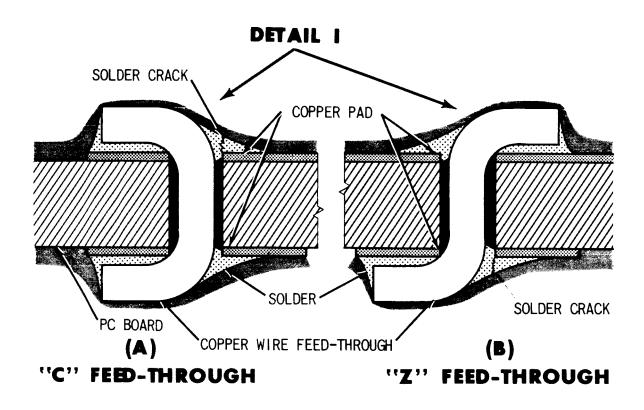
Figure 2. Double-Sided Circuit Board Failure Modes

- 1. One of the more frequent failure modes noted during this investigation was as depicted in figure 2. Both techniques (A and B) attempt to confine the expansion of the glass-epoxy board when a temperature differential appears and induces stress in the soldered connections. Figure 3A shows a component lead being used for a circuit feed-through and is subject to the same failure mode as described in figure 2. For mounting configurations as shown in figure 3A, it was noted that the solder cracked on the component side of the PC board, thus indicating that a clinched lead is stronger than the stud or non-clinched lead terminations.

5. The soft wire technique is shown in figure 9. This method provides a redundant path around the failure mode (figure 2B). The wire is soldered to the component lead, routed with strain relief, and soldered to the PC board copper circuit. Many variations of this method have been successfully employed to date.

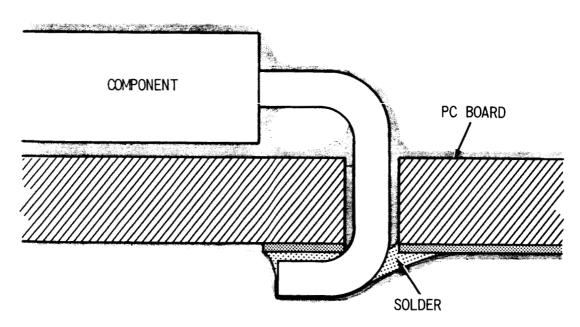
(B) SINGLE-SIDED CIRCUIT BOARD

- 2. Components mounted as shown in figure 3B seemed to produce little or no stress on their soldered connections. Strain relief is apparent on the component side of the PC board and conformal coating thickness did not seem to affect the integrity of the solder joint.

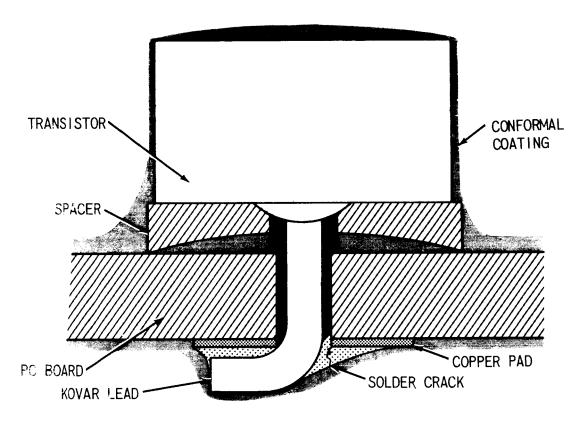
Figure 4. Transistor Mounting Configuration

formal coated is highly sensitive to solder cracking problems as shown in figure 4. This mounting method accounted for most of the cracked soldered connections observed during this solder joint investigation. The conformal coating tends to secure the component to the PC board (component lead is soldered to the other side of the PC board) and this action in conjunction with the effective increase in length of the PC board hole by the addition of the plastic spacer impregnated with polyurethane produces sufficient force to crack solder connections. In the absence of either the conformal coating or the plastic spacer, the forces generated during normal use are not great enough to crack their associated soldered connections.

4. The larger transistor case size (TO-5) is affected by this solder cracking mechanism more than the smaller case size (TO-18). One explanation for this fact is that the hole patterns drilled in PC boards are often the same for the TO-5 and TO-18 transistors and when routing the TO-18 leads into a hole pattern drilled for the larger TO-5, the leads

must be "spread-out" and thus strain relief is effected. Another factor may be the difference in the area of the two transistor cases. The conformal coating can exert more force on the larger case size than the smaller TO-18.

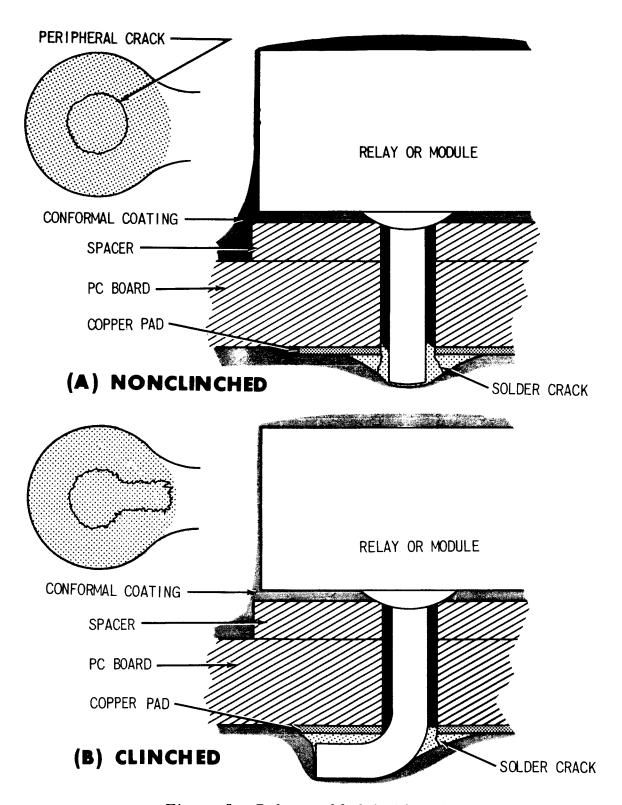
Figure 5. Relay or Module Mounting

5. Figure 5A shows a stud or nonclinched lead. This mounting configuration is used when the leads are too heavy and thus not practical to clinch. Electronic components that fall into this category are relays, modules, and magnetics. However there are many exceptions where the leads are smaller and clinching is used as seen in figure 5B. The failure mechanism is very similar to figure 4. The component lead is soldered to one side of the PC board and secured via the case which is conformal coated on the other side. The solder usually cracks around the heel of the lead with the crack visible on the surface of the solder and outlining the PC pad hole and the clinched portion of the lead (crack progresses from the hole area to clinched lead area).

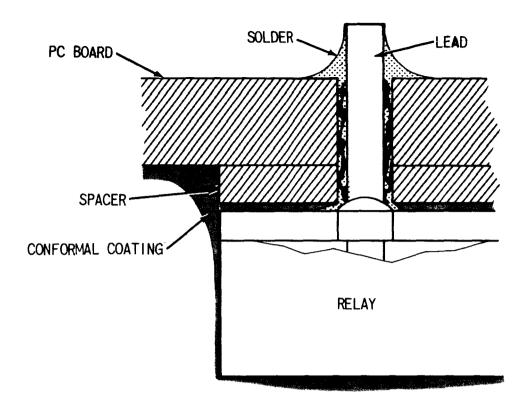
Figure 6. Relay Shorting Condition

- 2. During the early stages of the rework program, an important phenomenon was discovered which indicated caution must be exercised for all rework of soldered connections. The first indication of trouble was on a completely reworked PC board as it was being electrically functioned. This test indicated a low resistance path between a relay pin and its metal case. Additional testing revealed certain transistors (not using spacers in installation) also exhibited this same defect. Cross-sectioning revealed that solder had flowed down the relay pin and/or transistor lead and provided this low resistance path. This condition is shown on a relay in figure 6. Transistors that were installed with elevated spacers provided the necessary paths for the conformal coating (polyurethane) to saturate the glass header area thus preventing the above condition.

- 3. The theory is when a PC board assembly is soldered and conformal coated a partial vacuum is produced in the PC board holes through which the component leads protrude. Then anytime heat is applied to a soldered connection, the partial vacuum tends to be relieved and, in the process, pulls molten solder into the low pressure area. If in the application of the conformal coating, it seeped between the component case and the spacer, this problem would not exist (the area around the glass bead is filled with polyurethane and solder cannot short the lead). Spacers that provide a channel for the polyurethane to reach the pin-to-case junction area ensure electrical isolation during the rework process. During any rework program it must be first ascertained if the conformal coating will provide adequate electrical isolation; and, if not, the components must be removed, soldering operations completed, and conformal coating reapplied.

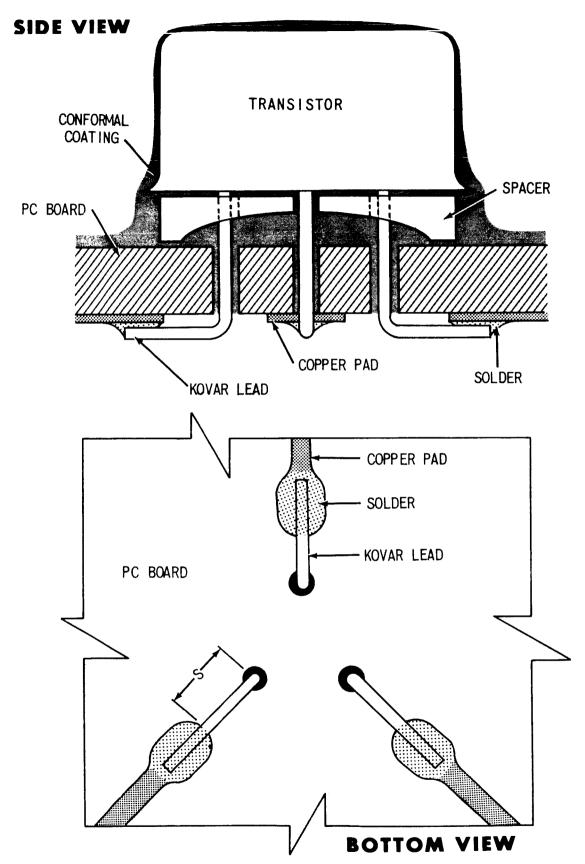
Figure 10. Transistor Mounting Using Lap Joint Technique

four different hole-to-copper-pad spacings (S, figure 10). The test results (after 250 temperature cycles of -65° to 170°F) indicate that for S-values 3/16 inch and greater no cracks and stresses appeared in the soldered connections. For S-values smaller than 3/16 inch the number of defects progressively increases.

1. A method that has received some testing in the Quality and Reliability Assurance Laboratory for providing strain relief for transistor mounting is shown in figure 10. The test configuration consisted of
